THAMES RIVER BASIN
THOMPSON , CONNECTICUT

QUADDICK RESERVOIR DAM
CT 00184

PHASE I INSPECTION REPORT
NATIONAL DAM INSPECTION PROGRAM

FEBRUARY , 1979

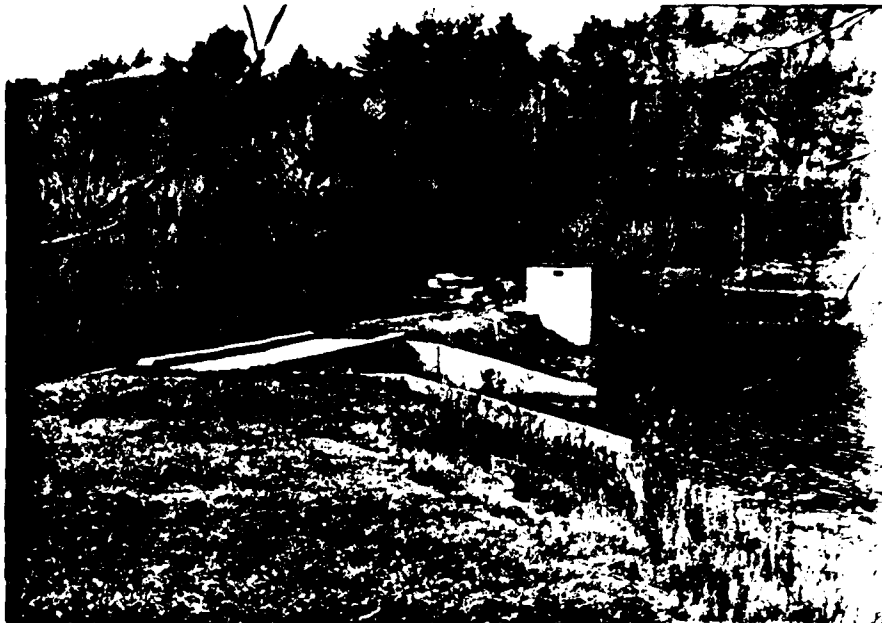
Overview of dam from left abutment

The right abutment (west) embankment was in good condition, with no leaks evident at the embankment itself or where it joins with the right spillway's masonry retaining wall. The crest of the dam was lower in this section and showed heavy vehicular wear. Riprap on the upstream face, particularly on the right embankment, was of rather small size, perhaps 1 cu. ft. on the average, and was somewhat randomly placed about 2 to 3 ft. below the crest. The crest itself was in good condition except as noted (see overview photos).

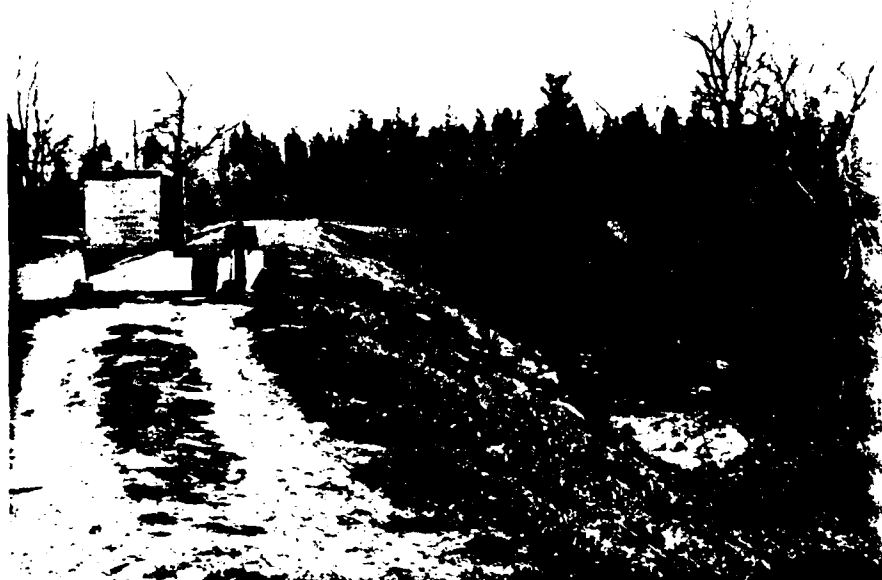
Overview of dam from right abutment

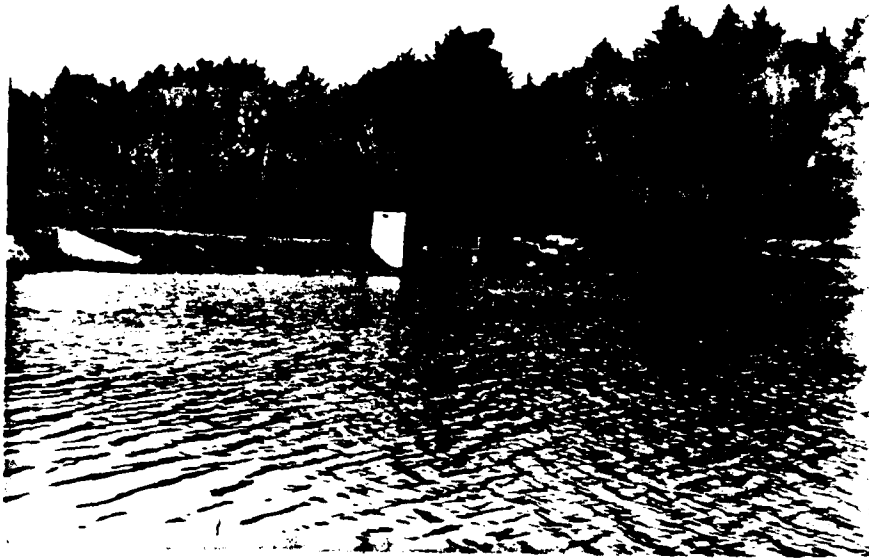
The west spillway is an old structure, built principally of ashlar masonry (Appendix C, Photo No. 3). There are later additions of concrete at the overflow weir and piers, stepped apron toe and spanning bridge (Appendix C, Photo No. 4). Stoplogs were not in place and about 3 in. of flow was being discharged through the spillway. This flow was cascading down the horizontal steps of the downstream apron, so that the condition of the floor could not be observed. The 1965 repair work to the apron involved anchoring the loose blocks in the lower part of the apron and covering the last step with reinforced concrete paving.

3. Gatehouse and right spillway from left abutment.

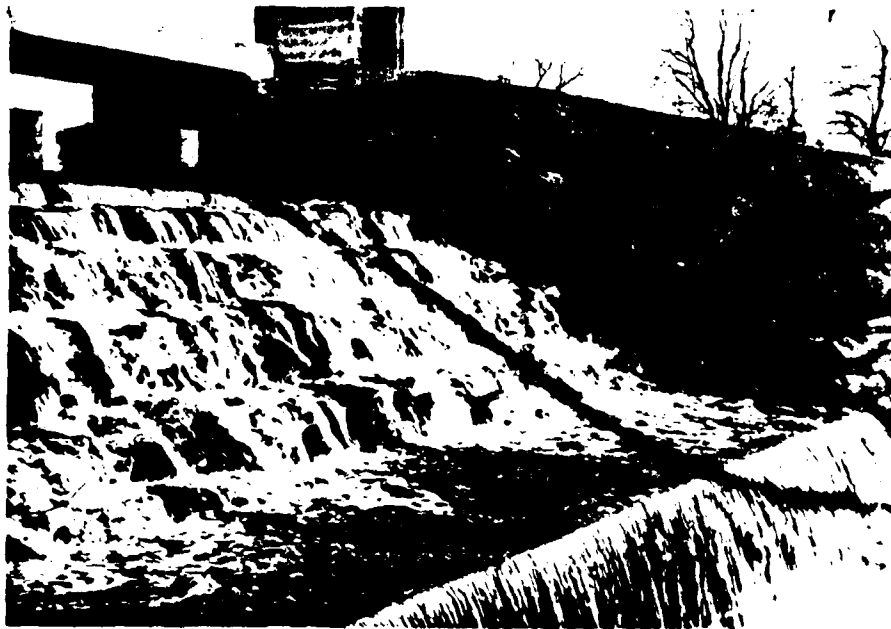
4. Downstream side of right spillway.

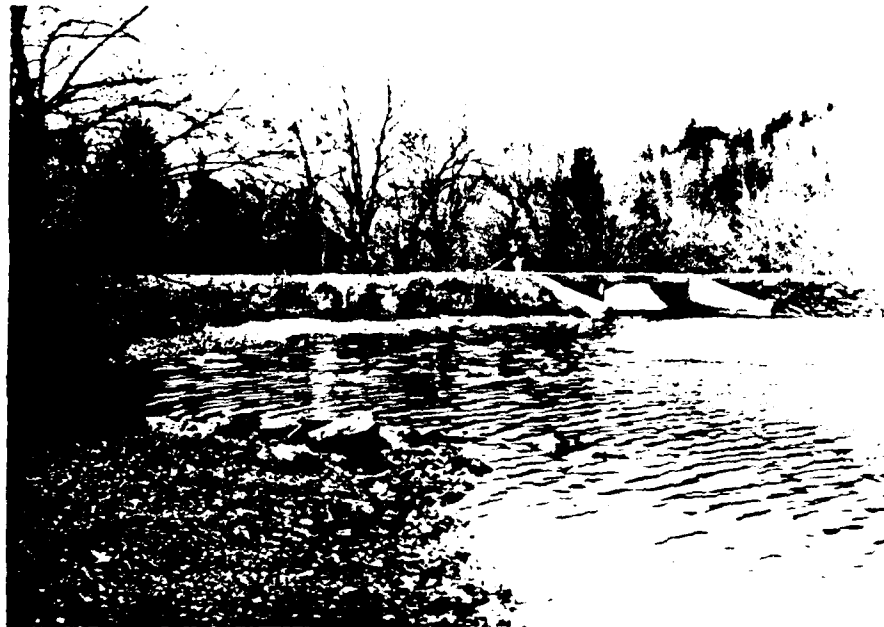
The east spillway was constructed in 1965; except for some cracking and spalling, it appeared to be in good condition (Appendix C, Photo Nos. 5 & 6). There was a large open crack, about $\frac{1}{2}$ in. wide at about the midpoint of the right inlet wall, undoubtedly owing to an unequal settlement of the wall footing. A large spall has occurred in the left downstream retaining wall, at the contraction joint about 14 ft. downstream from the crest. This spall was apparently the result of unequal deflections of the two adjacent wall panels, or because of binding owing to improper alignment of the joints during construction. Some spalling was also noted at the horizontal joint in the lower step, between the horizontal floor slab and the end wall below the slab.

5. Left spillway from left abutment.

10. Repair cracking and spalling of upstream and downstream retaining walls of east spillway.

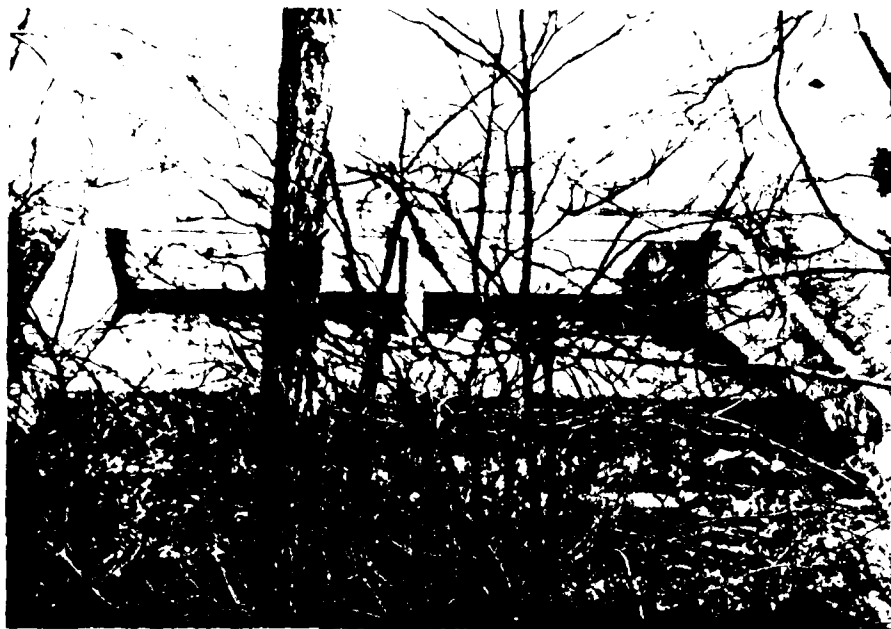
6. Left spillway from downstream channel.

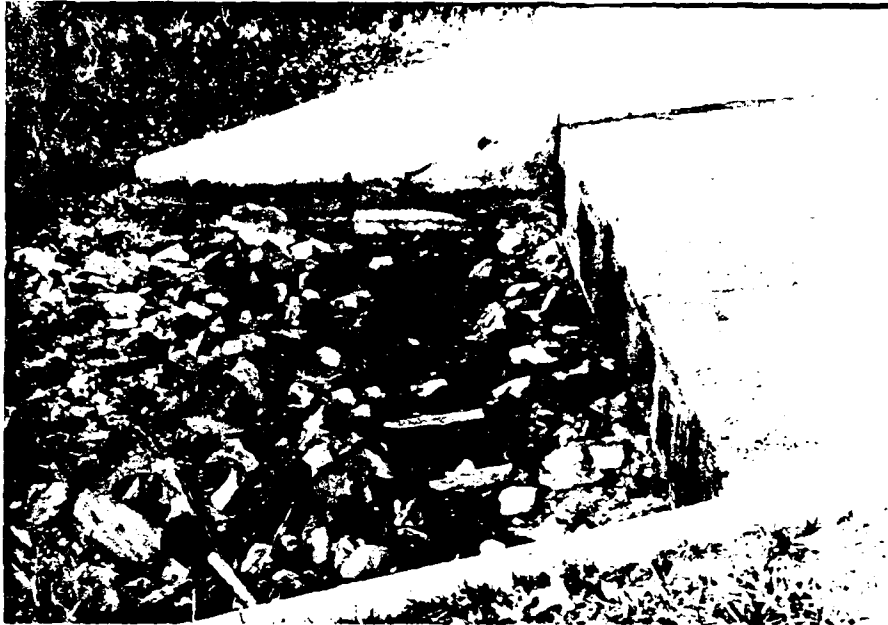
Riprap was specified on the design drawings downstream from the vertical step, to be placed to a level near the top of the step. Such riprap as was evident has washed down to about 3 ft. below the step (Appendix C, Photo No. 7). This condition was noted in the March 2, 1970, inspection report by John J. Mozzochi & Assoc. with the suggestion that the riprap be replaced. It is not known whether this suggestion was carried out or whether the riprap has since become eroded again.

7. Displaced, undersized riprap in downstream channel of left spillway.

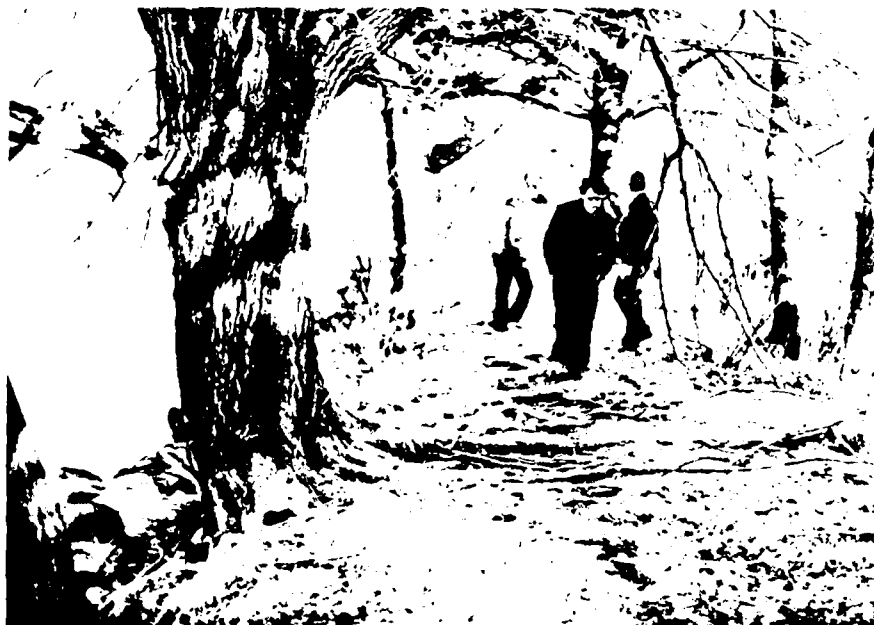
An earth dike closes off a low swale along the reservoir rim about 2,000 ft. east of the main dam. The dike spans a distance of about 190 ft., with its crest about 1.5 ft. lower than the main dam. The dike has a top width of about 10 ft., with approximately 2 to 1 side slopes. The area for about 150 ft. to each side of the dike is at about the same elevation as the top of the dike, and a number of homes are sited along this reach of the reservoir shoreline. The swale area below the dike appeared quite marshy, but it could not be ascertained how much of the swampiness was caused by seepage either through or under the dike (see Appendix C, Photo Nos. 9 & 10).

10. View along crest of dike
